## NEW DIAGNOSTIC TOOLS FOR HIGH VOLTAGE BUSHINGS

M. Krüger<sup>1\*</sup>, A. Kraetge<sup>1</sup>, M. Koch<sup>1</sup>, K.Rethmeier<sup>1</sup>, M. Pütter<sup>1</sup>, L. Hulka<sup>1</sup>, N. Koch<sup>2</sup>, M. Muhr<sup>3</sup>, C. Summereder<sup>3</sup>  
<sup>1</sup>OMICRON Energy, Klaus, Austria <sup>2</sup>MICAFIL, Zürich, Switzerland, <sup>3</sup>TU Graz, Austria

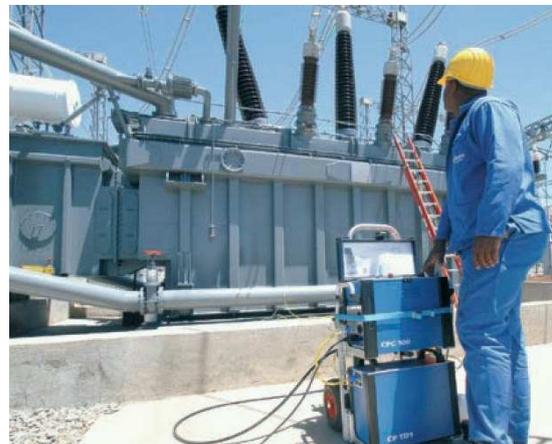
Figure 2: On-site Dielectric Response measurement of HV bushings from 15 to 400Hz

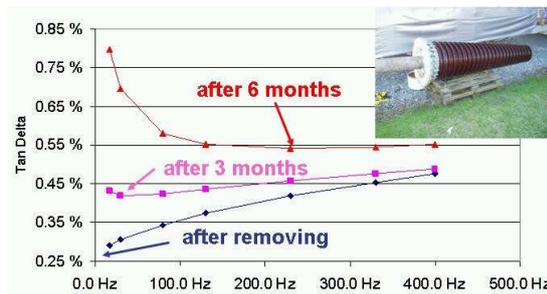
Figure 4: Dielectric Response of a RIP bushing exposed to moisture

The non protected oil side was getting humid during the months and the change of the  $\tan\delta$  can be seen clearly. The moisture increases the  $\tan\delta$  particularly at low frequencies, the minima of the  $\tan\delta$  curves are shifted to higher frequencies with increasing moisture content.

The curves are rather flat, the minimum of the curves is below the lowest test frequency of 15Hz. The values at 50Hz are fulfilling the limits in table 1. In figure 4 a RIP bushing can be seen, which was stored outside without any protection of the oil side.

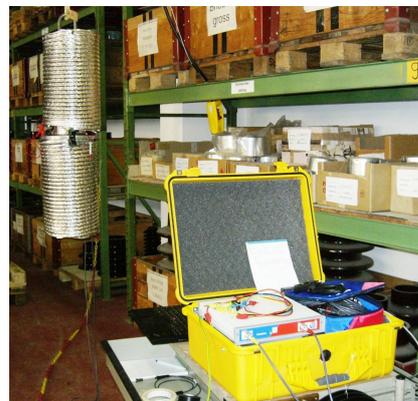
Figure 11: Combined FDS-PDC measurement on a RIP bushing with an Aluminium shield for interference protection

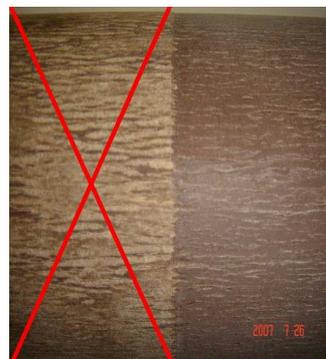
The bushings come normally in a wooden box with some Silicagel in a small bag. A lot of bushings are stored in those boxes for many years, some of them in a humid environment. The bushing is protected against penetrating water on the outdoor side, but on the oil side they are not protected. On this side the resin surface can be damaged by incoming water. In figure 16 the difference between a proper resin surface and a surface which is damaged by water is shown.

Figure 16: Resin surface damaged by water

Bushings with those damaged surfaces shouldn't be used again [5].
